# **NON-INVASIVE GROUND-PENETRATING RADAR INVESTIGATION OF A FAILING CONCRETE FLOOR SLAB.**

Martin L. King, Dany P. Wu and Dr. David C. Nobes

*GPR Geophysical Services – New Zealand  
PO Box 6056, New Plymouth, New Zealand.  
mking@geosurvey.co.nz*

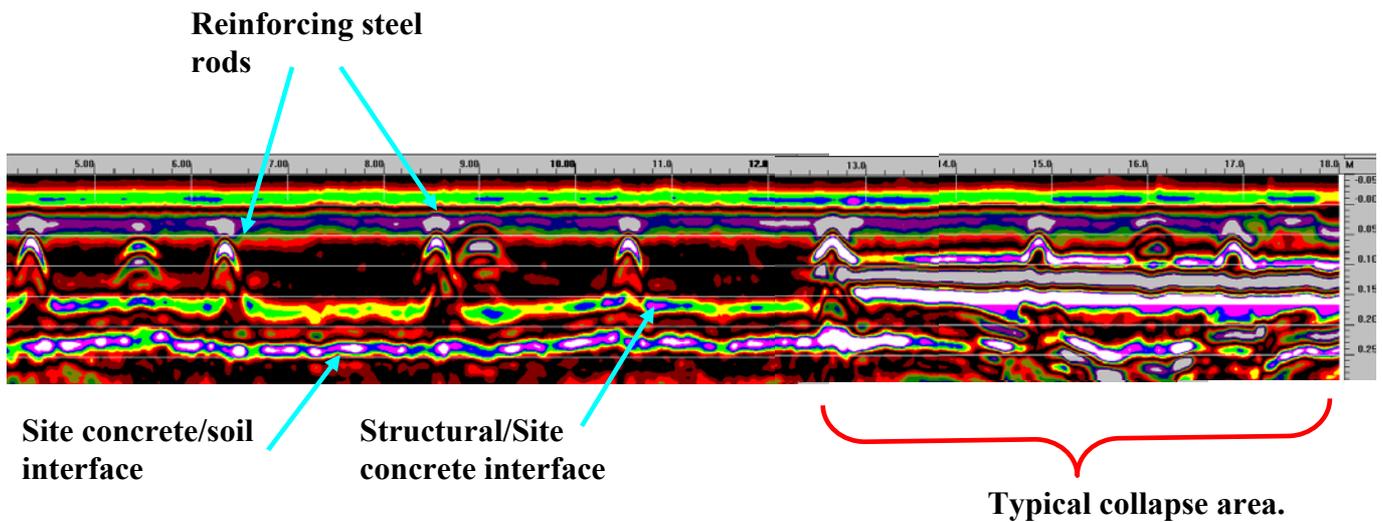
The resultant data clearly identified areas where voids had formed. It further enabled these demarcated areas to be classified as shallow and/or significant void zones. The site concrete/structural layer, under the structural layer, had collapsed into the void were obvious.

Figure 3 – Radargram showing cross-section through tank concrete base.  
Scan taken prior to repair.

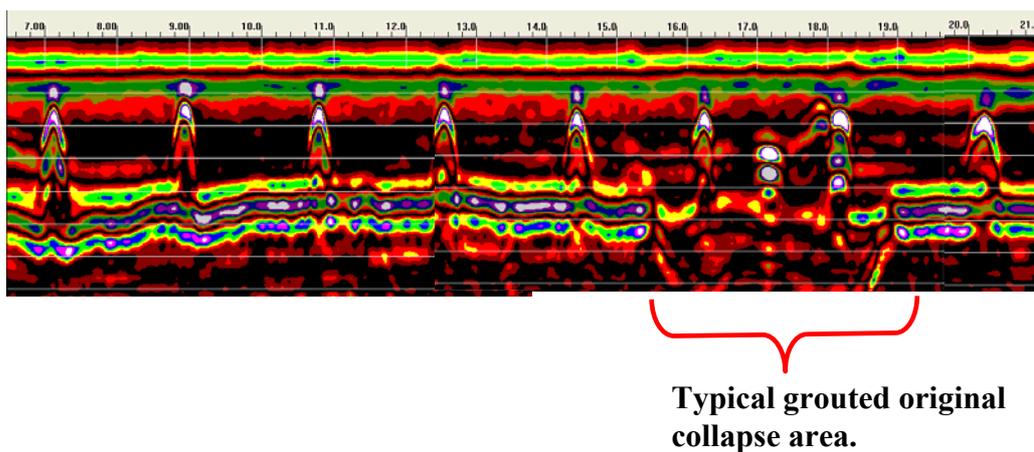
Figure 4 - Radargram showing cross-section through tank concrete base.  
Scan taken after repair.

A scaled AutoCad drawing was used to delineate the detected voids, large and small, enabling accurate targeting of sub-base voids for repairs without risk of serious damage to the tank floor. Precisely positioned 50 mm diameter holes were drilled through the base and specially prepared grout was used to fill the voids. The extent to which each grouting operation was successful could also be monitored. A final radar survey was used to confirm successful elimination of the cavities.

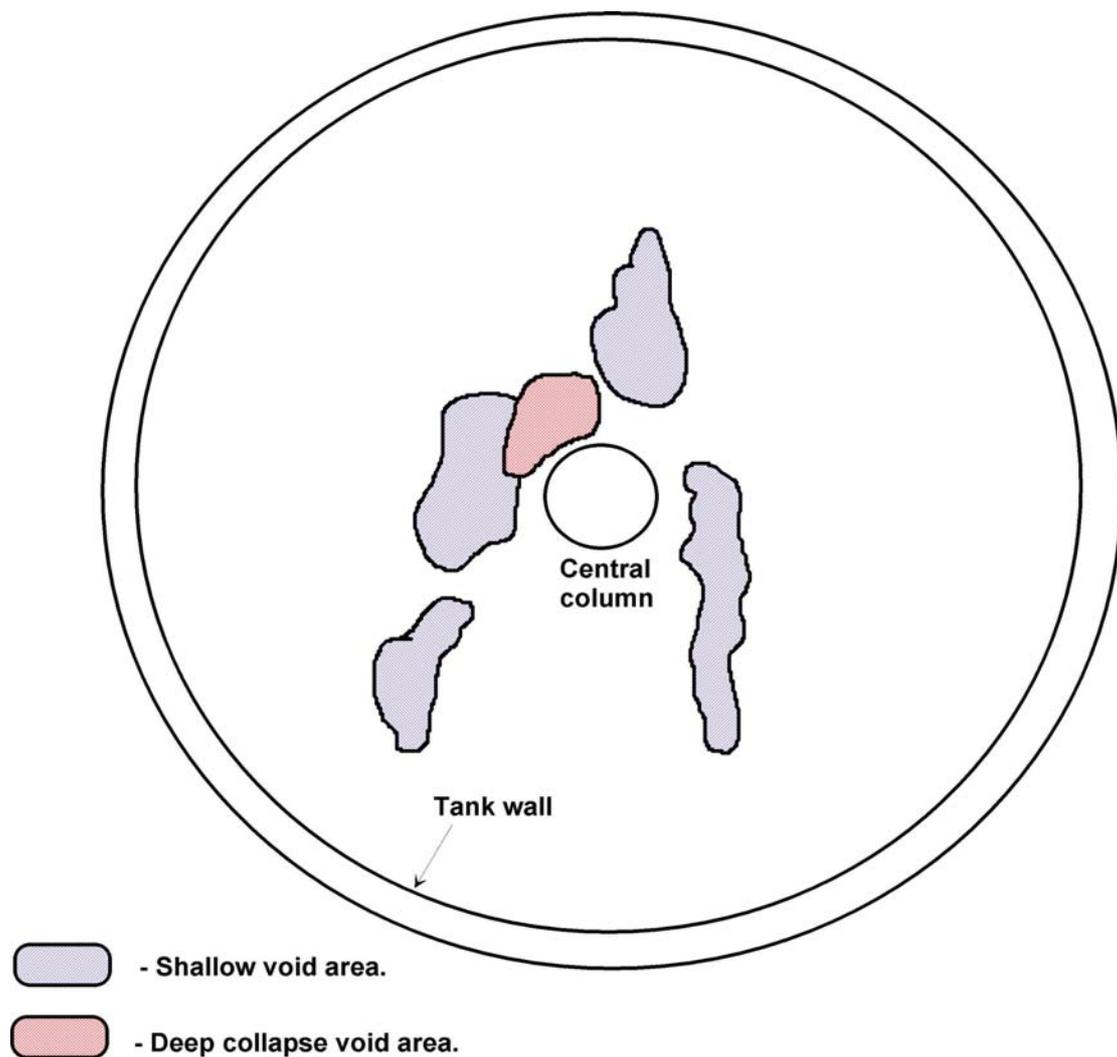
**Figure 5 – Plan view of typical void location plotted to scale using radargram results.**
