# **NON-INVASIVE GROUND-PENETRATING RADAR INVESTIGATION OF A FAILING CONCRETE FLOOR SLAB.**

Martin L. King, Dany P. Wu and Dr. David C. Nobes

*GPR Geophysical Services – New Zealand  
PO Box 6056, New Plymouth, New Zealand.  
mking@geosurvey.co.nz*

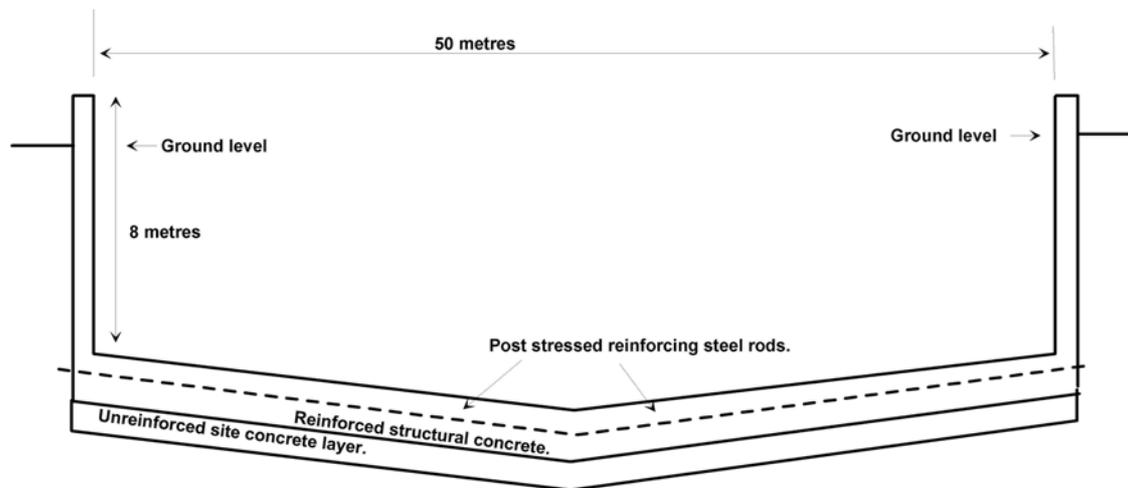
This study concerns a New Zealand wastewater treatment facility which uses large settling tanks, 50 m in diameter, 8 m deep, each holding approximately 14,000 cubic metres of untreated waste liquid. The concrete tank construction consists of a segmented precast concrete wall with a 300 mm thick concrete floor base. The tank floor base consists of an unreinforced 100 mm thick concrete site base slab overlaid by a 200 mm thick, steel reinforced, structural concrete floor slab.

**Figure 1 – Wastewater tank cross-section construction detail.**

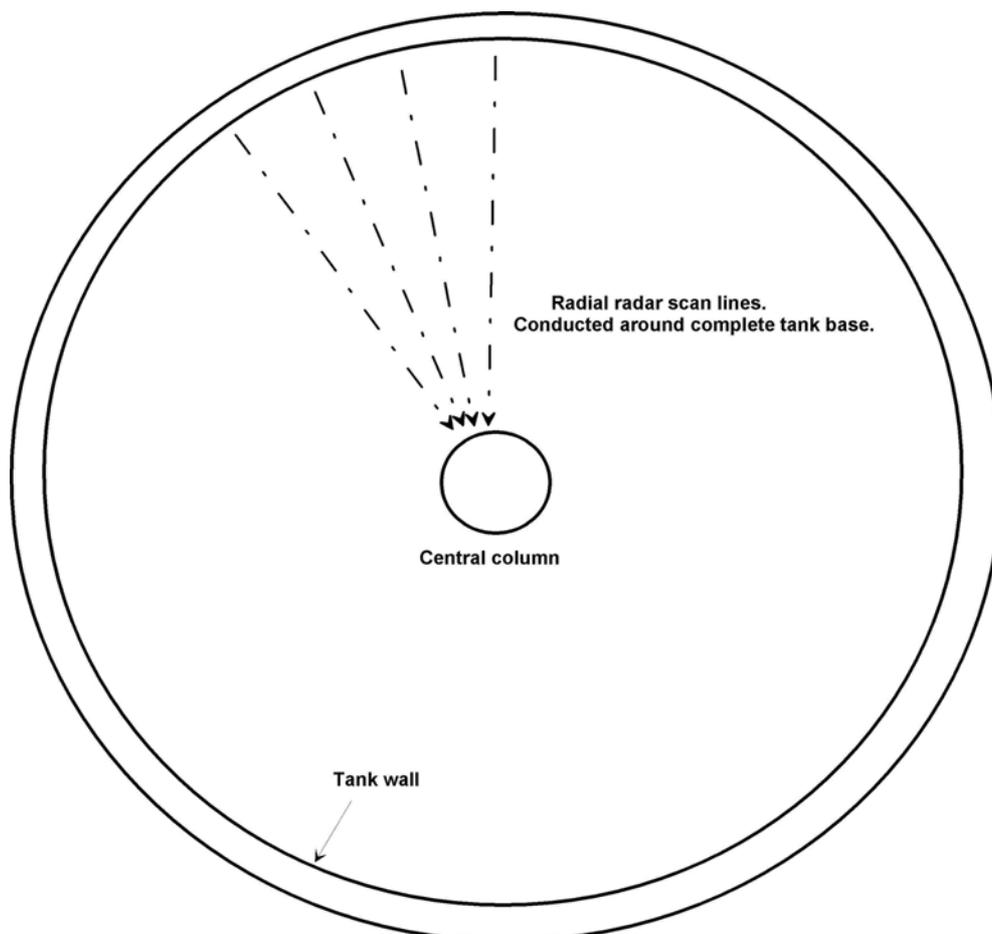
Radar scans were conducted along radial lines commencing at the tank wall and moving towards the tank centre. The resultant radargrams were then analysed and a drawing produced of the suspected subsurface void areas.

**Figure 2 – Plan view of Tank showing radar scan lines.**

A scaled AutoCad drawing was used to delineate the detected voids, large and small, enabling accurate targeting of sub-base voids for repairs without risk of serious damage to the tank floor. Precisely positioned 50 mm diameter holes were drilled through the base and specially prepared grout was used to fill the voids. The extent to which each grouting operation was successful could also be monitored. A final radar survey was used to confirm successful elimination of the cavities.
